# Indian Island Cultural & Environmental Restoration Project

## Erosion Control

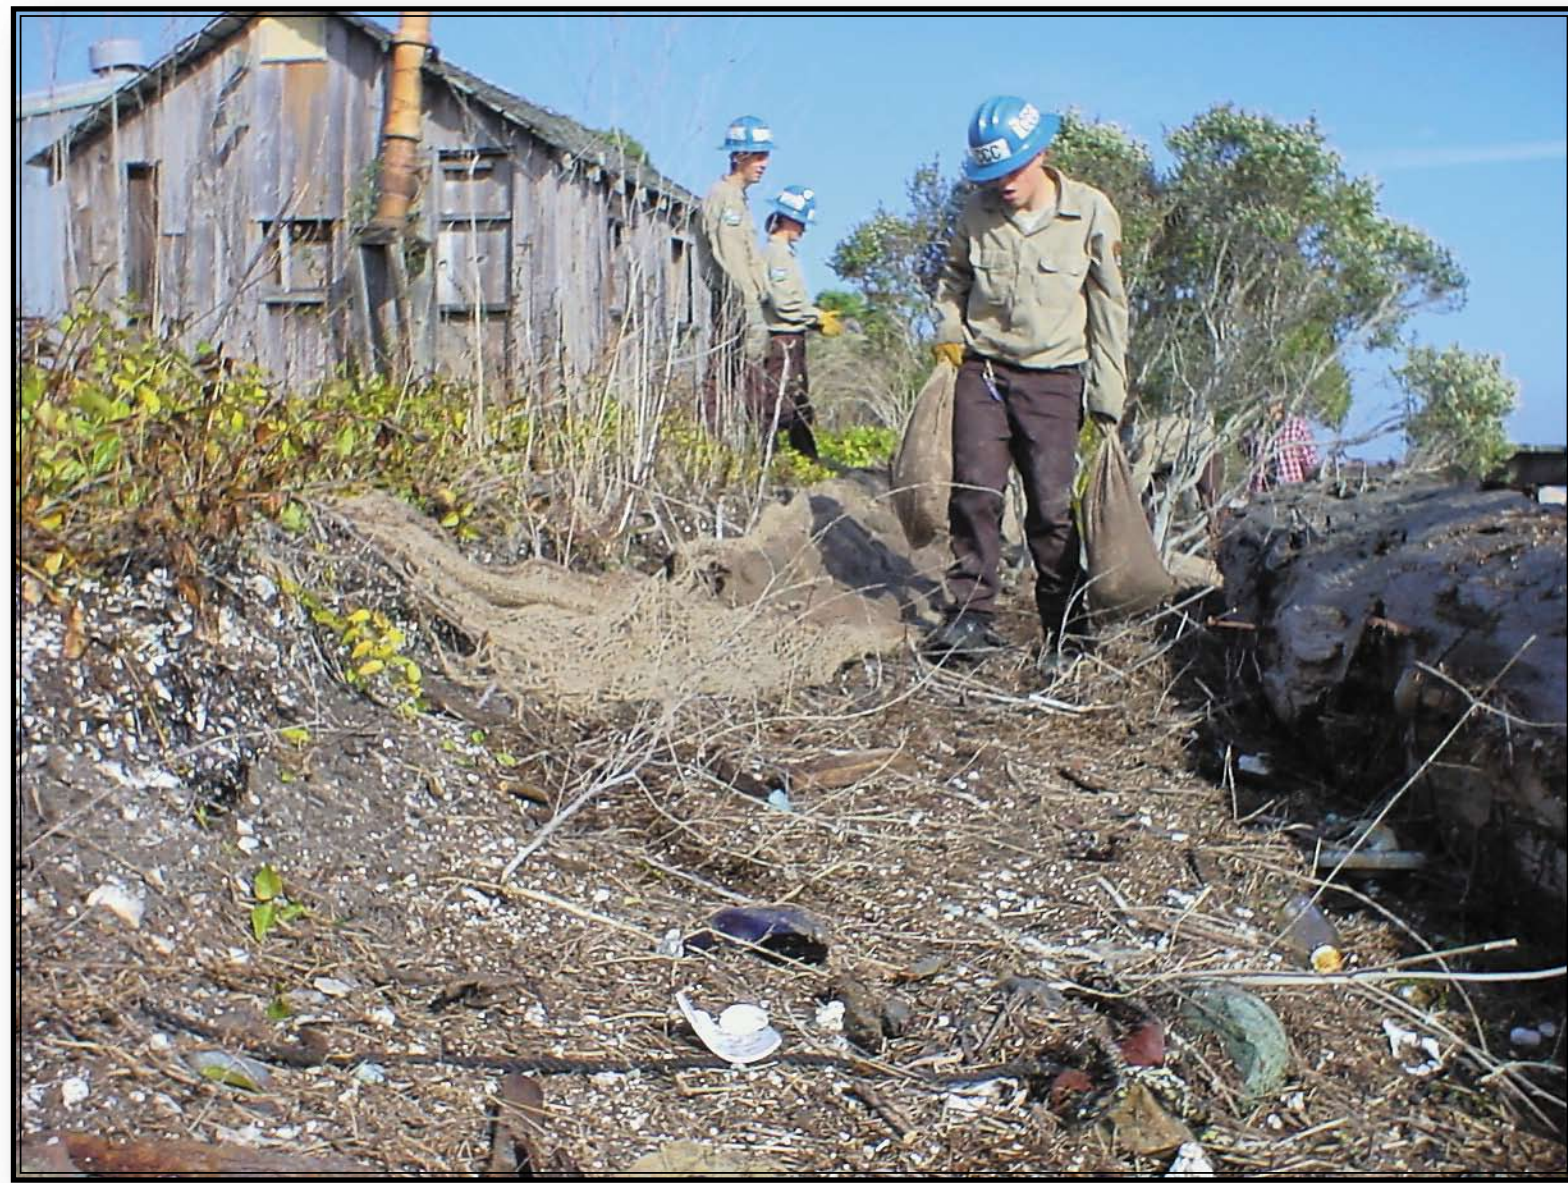
CCC Member Placing Oyster Shell-Filled Bags on Shell Mound, 2002

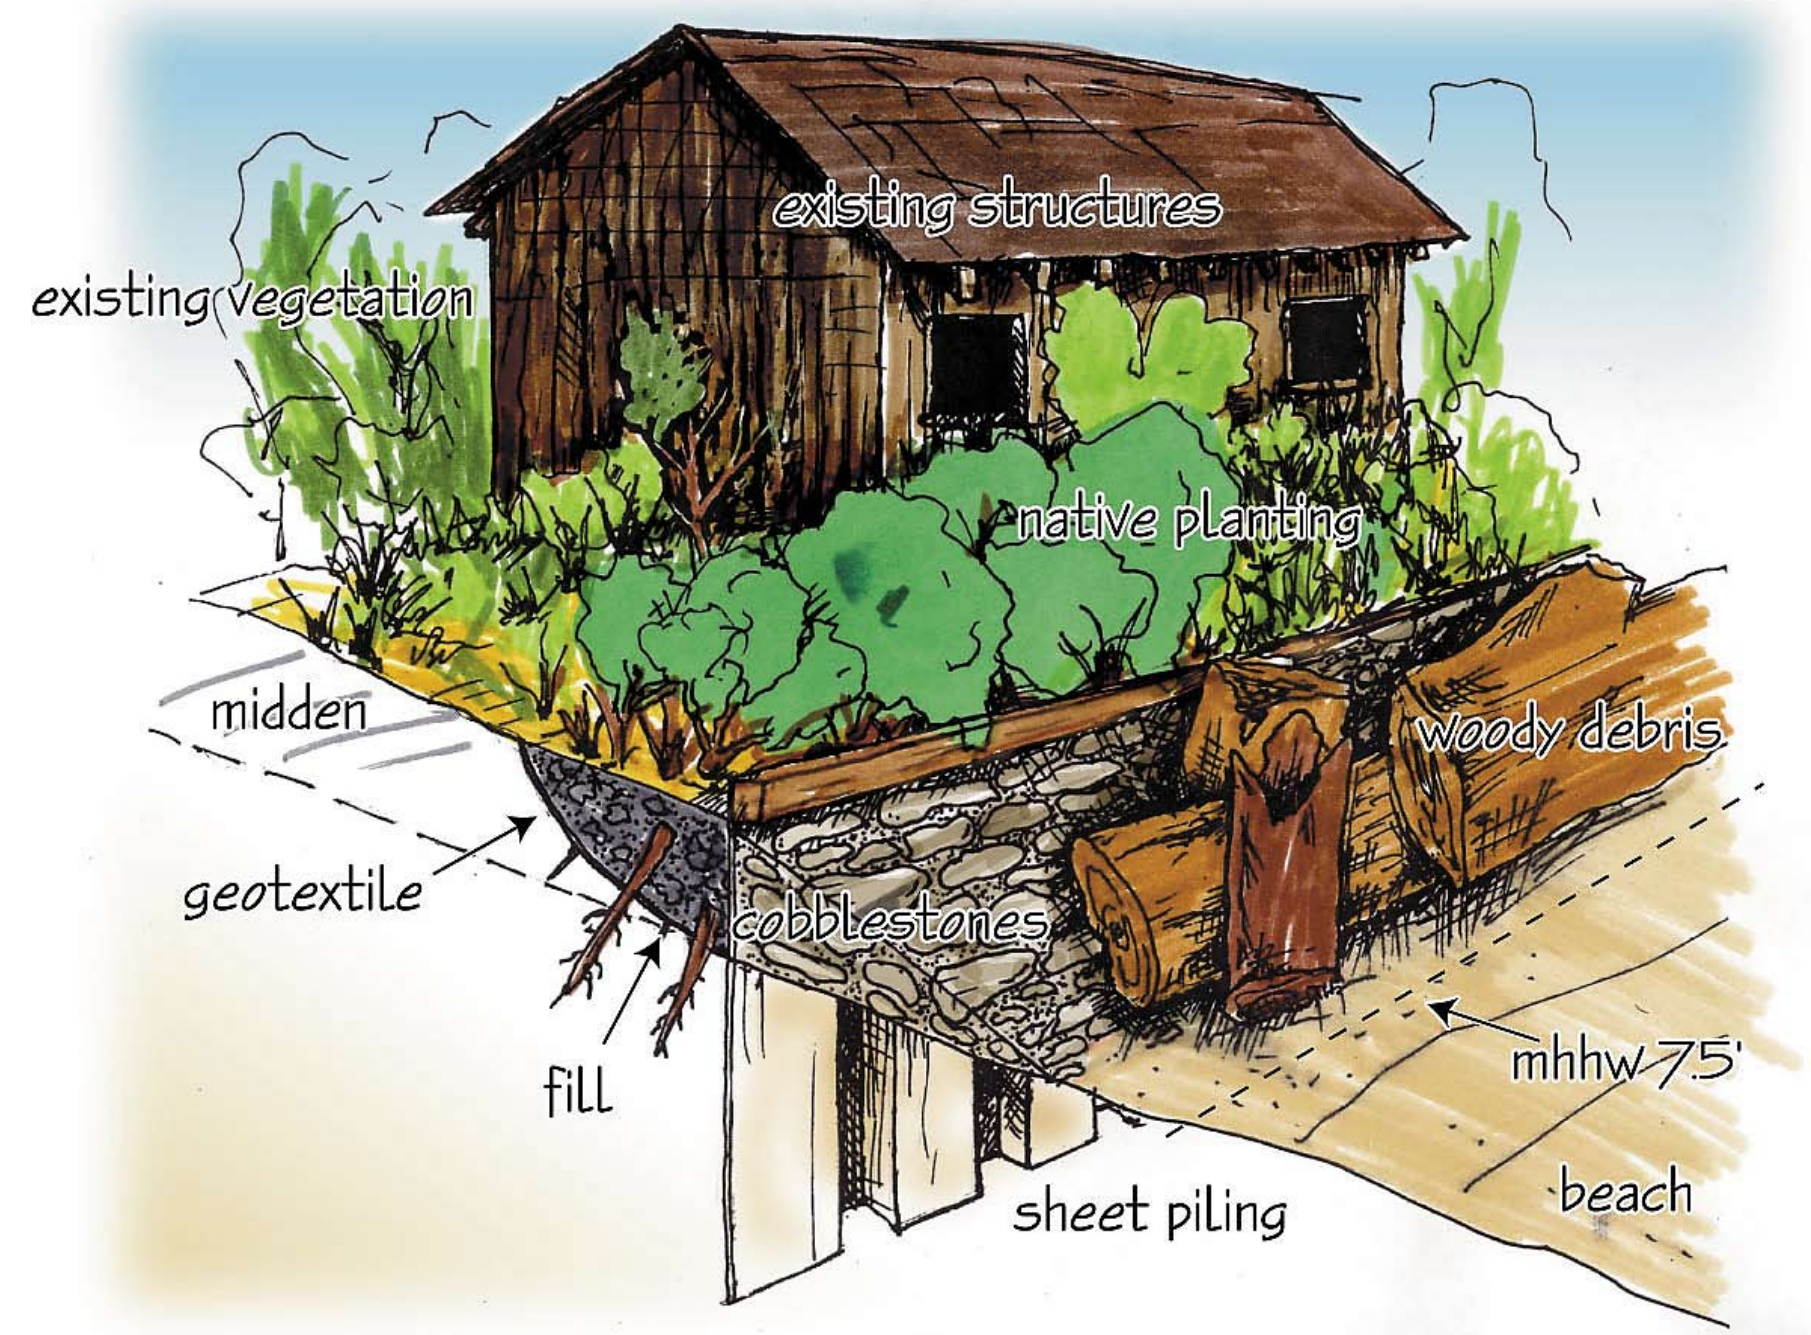
Illustrative Cross Section of Erosion Control on South Side of Project Site

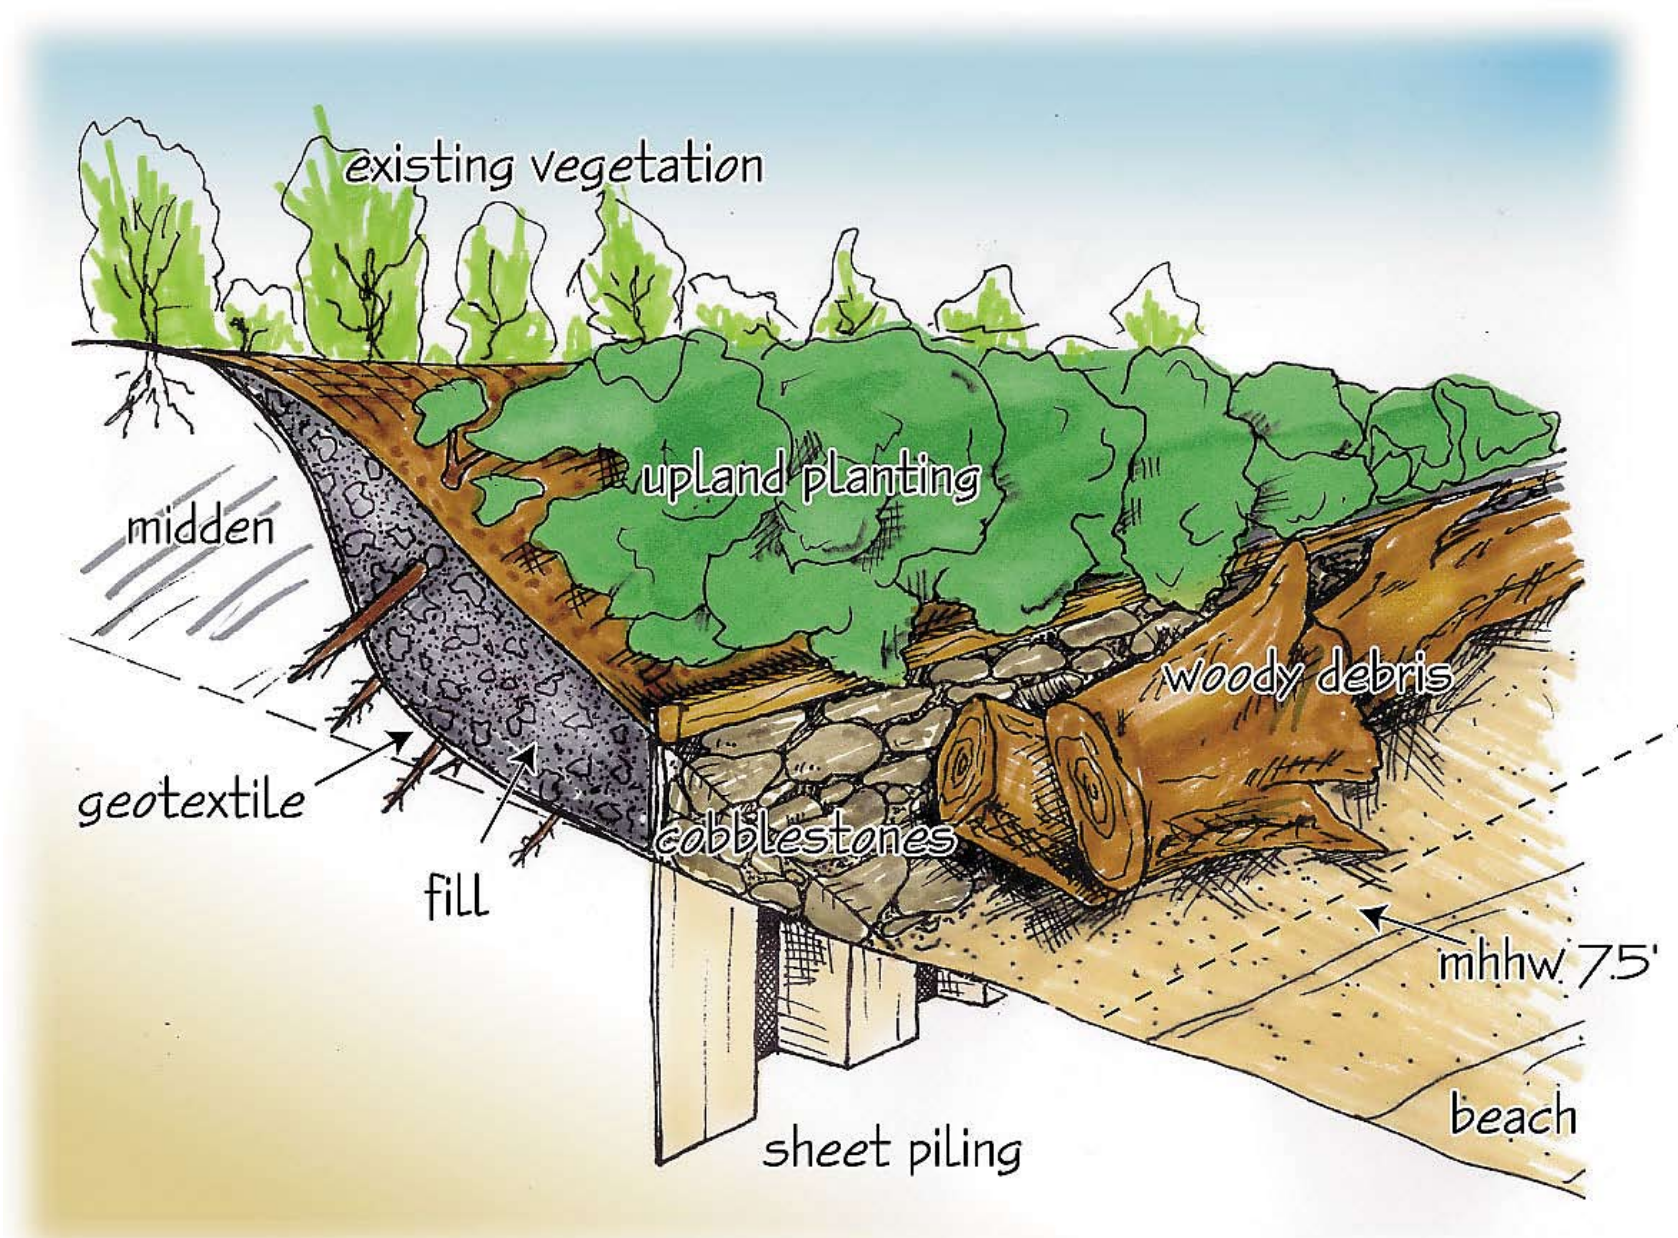
Illustrative Cross Section of Erosion Control on North Side of Project Site

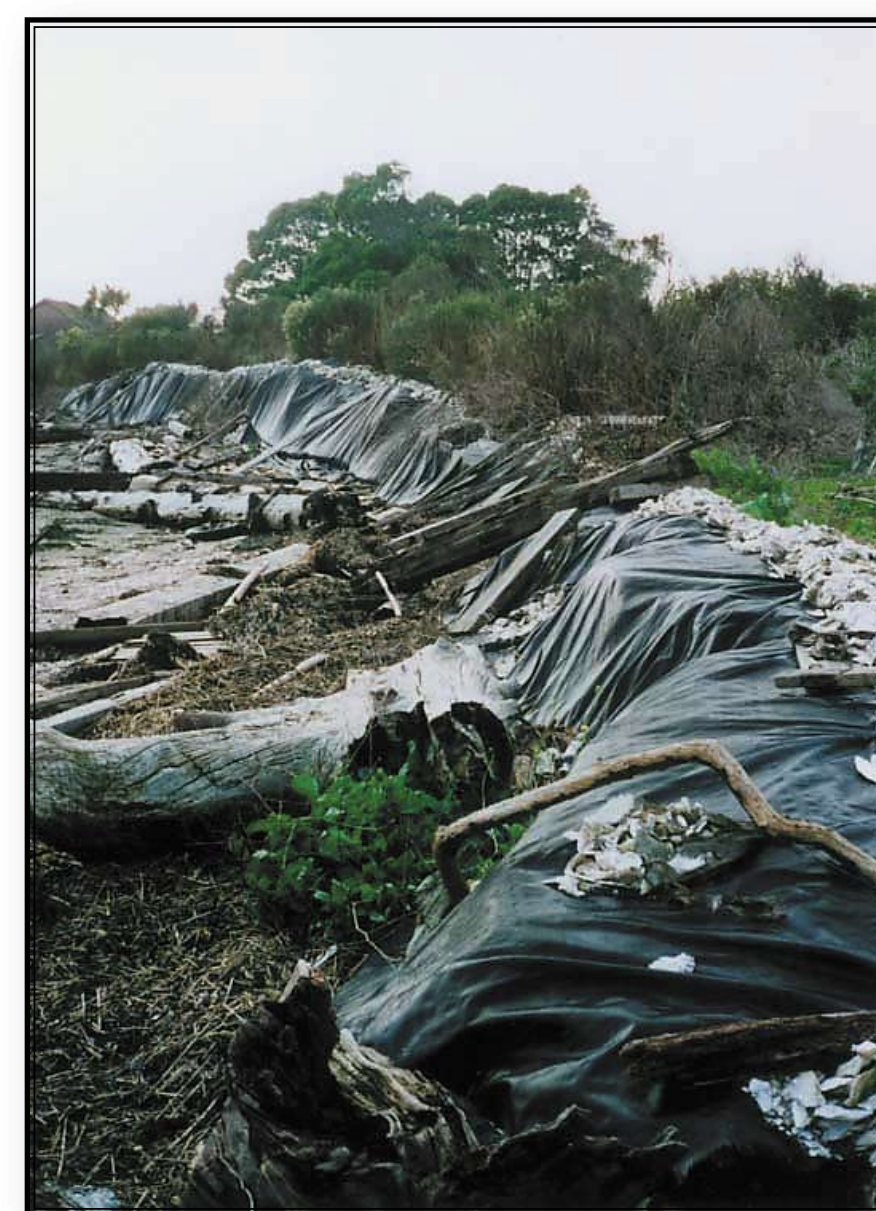
Deteriorated Temporary Erosion Control, Looking Southwest, 2002

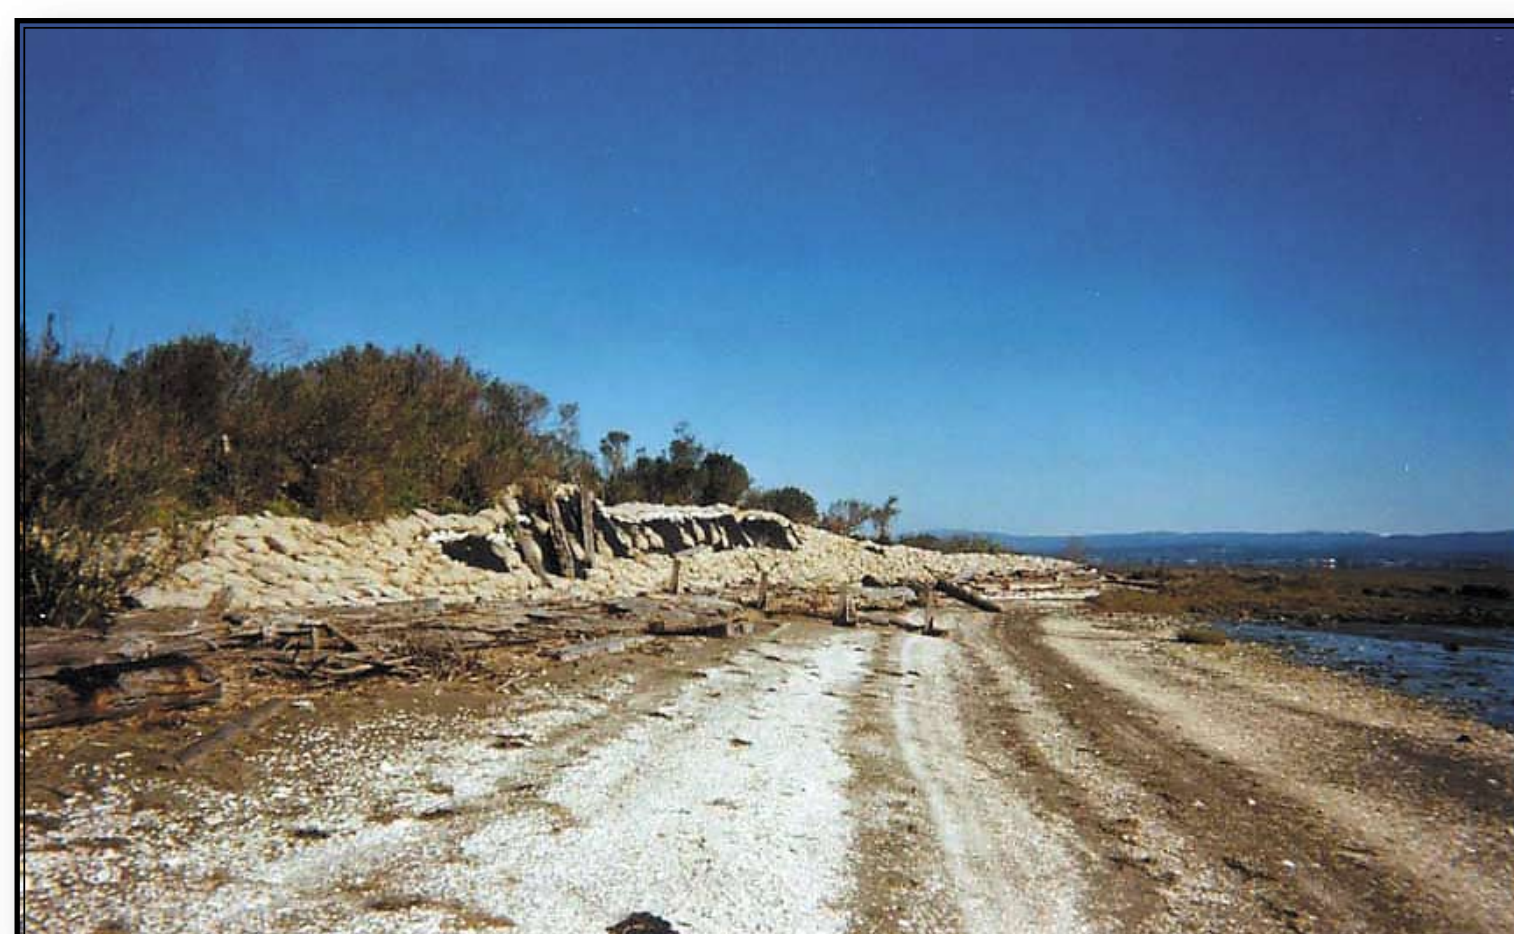
View Northeast of Erosion Control on the Shell Mound, 2002
